# Troubleshoot VRRP Active-Active Issue in Viptela SD-WAN Router

This document describes how to resolve the Viptela SD-WAN router Virtual Router Redundancy Protocol (VRRP) stuck in the Active-Active state.

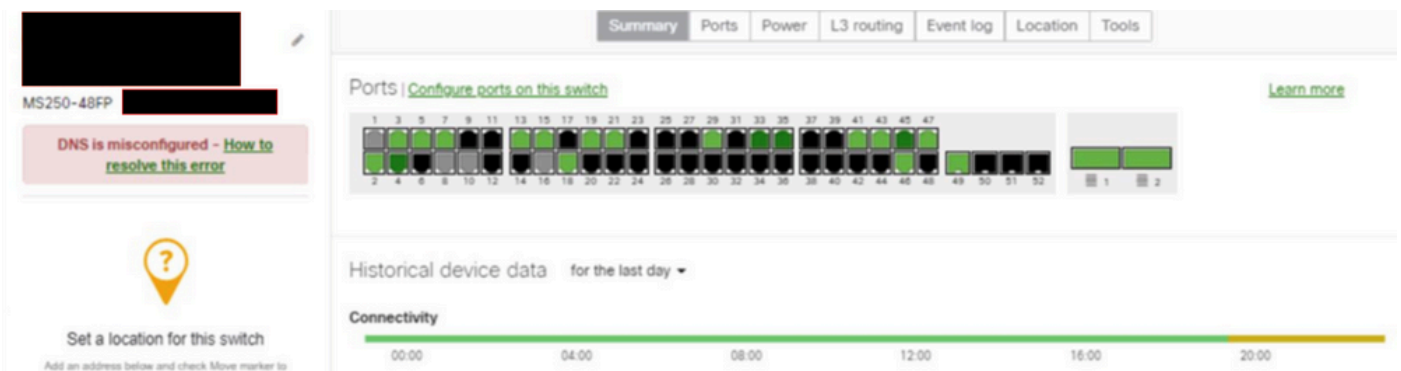
Switch 2 which connected to VE2 was alerted for “DNS is misconfigured” in the Meraki dashboard.

Meraki dashboard indicates that AP4 and AP3 are in repeater mode which is connected to uplink switch2 which gets the alert for bad DNS.

To confirm the Stack status, open Meraki TAC as the stack communication messages is visible only to Meraki TAC. On verification, it is identified that intra-stack communication issues between the primary and secondary switches in the stack.

Meraki also confirmed this issue was caused by the VRRP packet from VE1 not reached to VE2 via Stack member switch1(primary) through stack member 2. This is a known issue in the 12.28 code.

1. Reload all the member switches in the stack (temporary fix).
2. Upgrade the Meraki Switch firmware to the latest stable build.
