Troubleshoot ASR 9000 Series Punt Fabric Data Path Failures

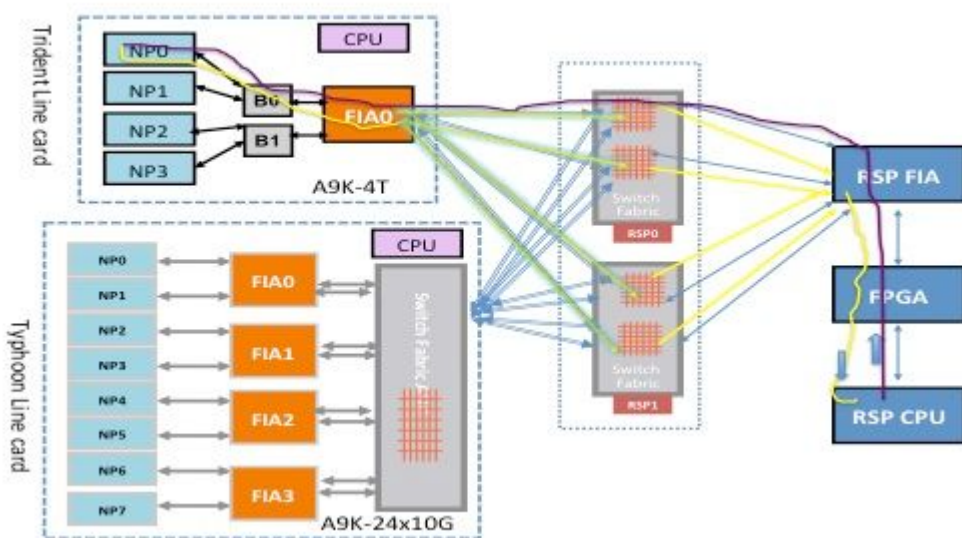
Punt Fabric Diagnostic Packet Path on the Trident-Based Line Card

This diagram depicts the route processor sourced diagnostic packets destined to an NP that is looped back towards the route processor. It is important to note the data path links and ASICs that are common to all NPs, as well as links and components that are specific to a subset of NPs. For example, the Bridge ASIC 0 (B0) is common to NP0 and NP1, while FIA0 is common to all NPs. On the route processor end, all links, data path ASICs, and the Field-Programmable Gate Array (FPGA) are common to all line cards, and hence to all NPs in a chassis.

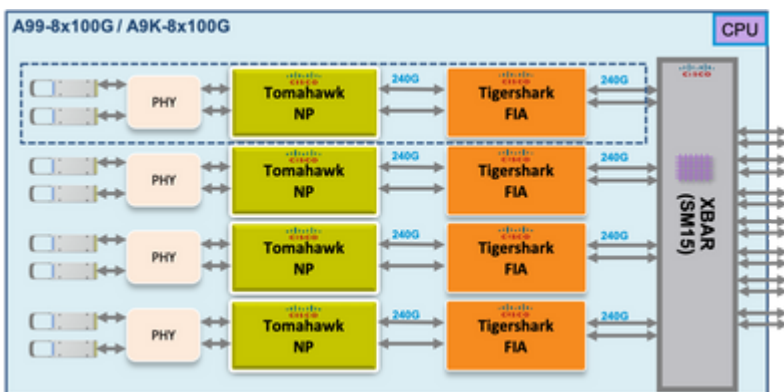
On Tomahawk line cards there is 1:1 connectivity between the FIA and the NP.

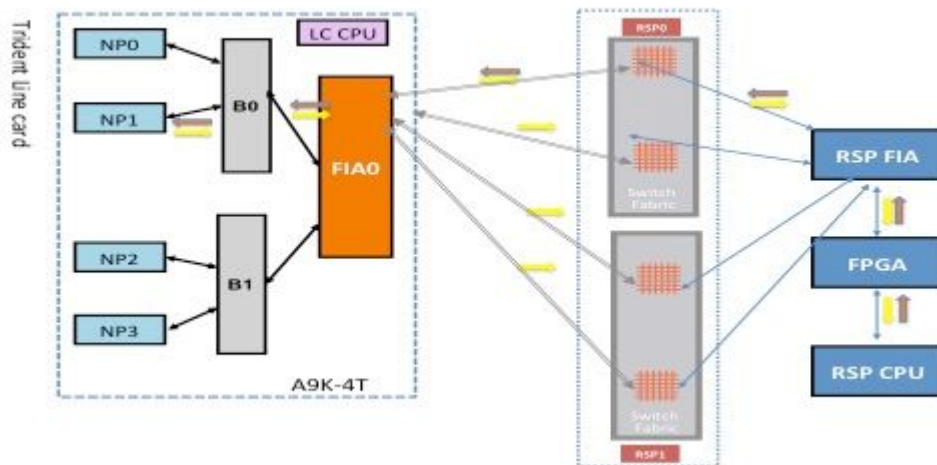
Fabric Diagnostic Path

and the line card slot is used for the packet from the route processor towards the line card. The returned packet from NP1 can be sent back to the active route processor over any of the two fabric link paths between the line card slot and the active route processor. The choice of which one of the two links to use depends on the link load at that time. The response packet from NP1 towards the standby route processor uses both links, but one link at a time. The choice of the link is based on the header field that the diagnostic application populates.

Refer to the NP0 Diagnostic Failure Analysis section, but apply the same reasoning for NP1 (instead of NP0).

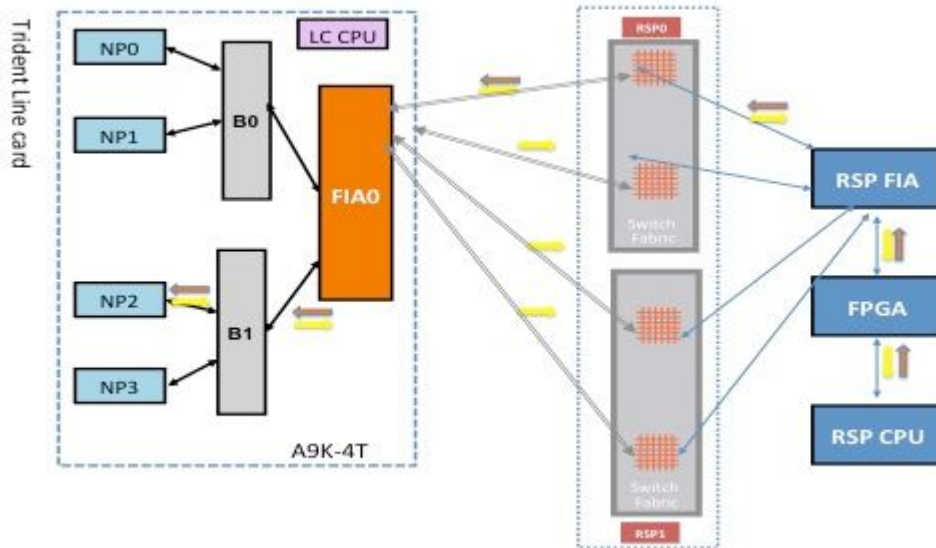
Fabric Diagnostic Path

Make note of the packet path from the route processor card towards NP2. Although there are four links to use for packets destined towards NP2 from the route processor, the first link between the route processor and the line card slot is used for the packet from the route processor towards the line card. The returned packet from NP2 can be sent back to the active route processor over any of the two fabric link paths between the line card slot and the active route processor. The choice of which one of the two links to use depends on the link load at that time. The response packet from NP2 towards the standby route processor uses both links, but one link at a time. The choice of the link is based on the header field that the diagnostic application populates.

Refer to the NP0 Diagnostic Failure Analysis section, but apply the same reasoning for NP2 (instead of NP0).

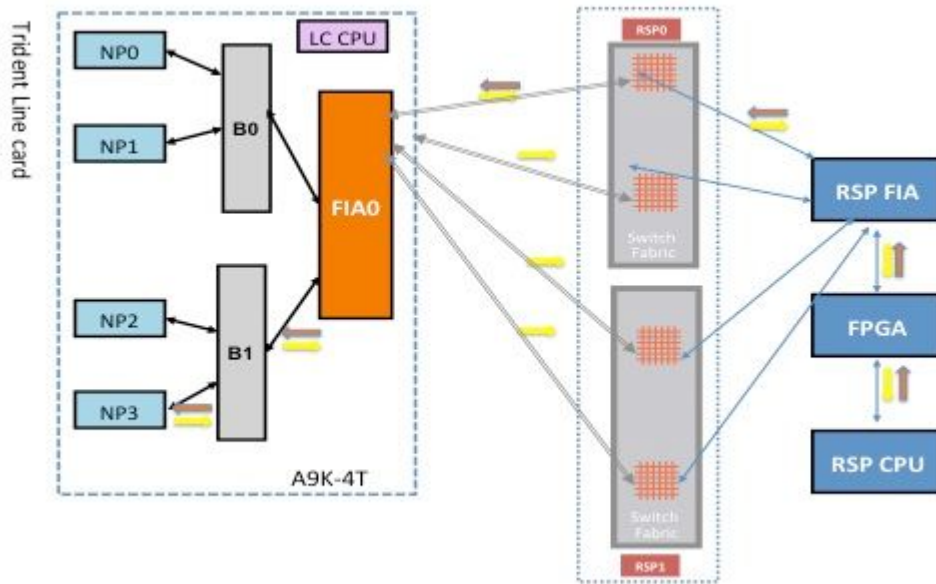
Fabric Diagnostic Path

Make note of the packet path from the route processor card towards NP3. Although there are four links to use for packets destined towards NP3 from the route processor, the first link between the route processor and the line card slot is used for the packet from the route processor towards the line card. The returned packet from NP3 can be sent back to the active route processor over any of the two fabric link paths between the line card slot and the active route processor. The choice of which one of the two links to use depends on the link load at that time. The response packet from NP3 towards the standby route processor uses both links, but one link at a time. The choice of the link is based on the header field that the diagnostic application populates.

Refer to the NP0 Diagnostic Failure Analysis section, but apply the same reasoning for NP3 (instead of NP0).
