Cisco ONS 15454 DWDM Troubleshooting Guide

Product and Software Release 8.0
June 2012

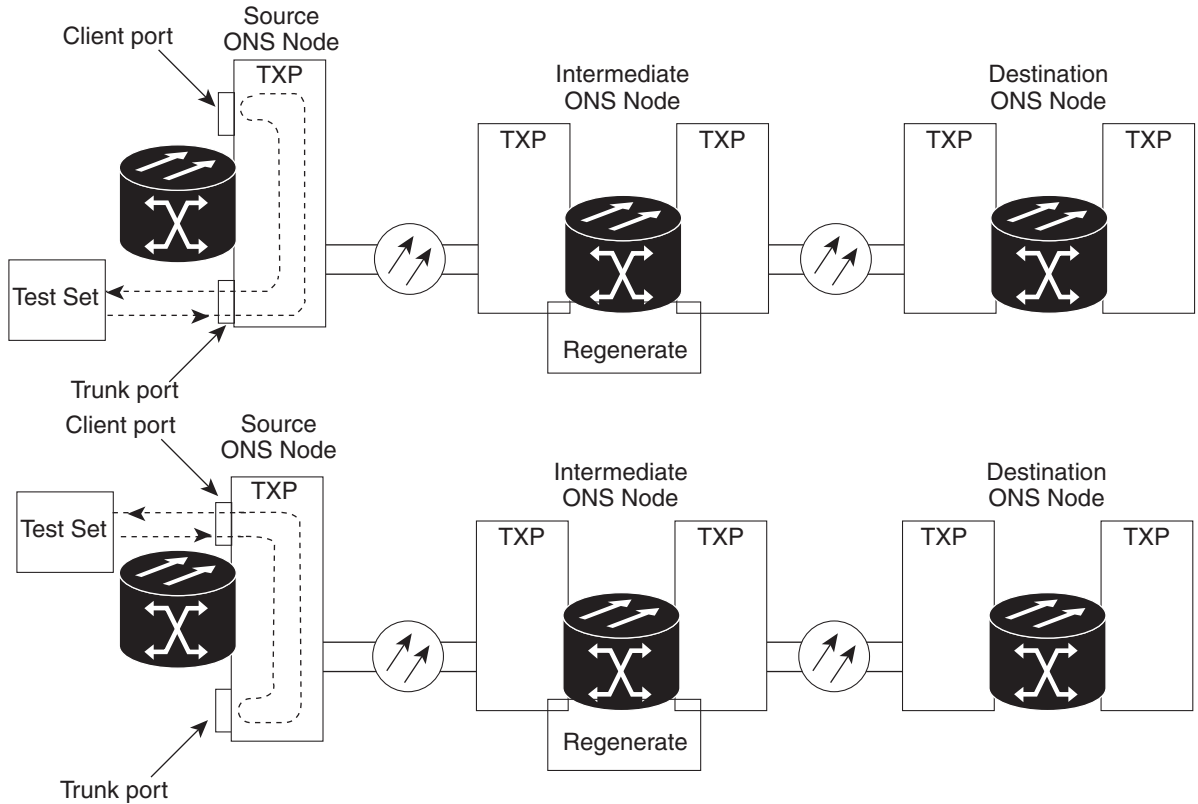
The terminal loopback test is performed on the node source MXP, TXP, or ADM-10G muxponder or transponder port. For the circuit in this example, it is the source TXP trunk port or a client port in the source node. Completing a successful terminal loopback to a node source port verifies that the circuit is through the source port. [Figure 1-4](#) shows an example of a terminal loopback on a source TXP port and a client TXP port.

Figure 1-4 Terminal Loopback on a Source-Node MXP or TXP Port
