# Cisco Nexus 5500 Series NX-OS Software Upgrade and Downgrade Guide, Release 7.3(11)N1(1)

**First Published: February 18, 2022**

This document describes how to upgrade or downgrade Cisco NX-OS software on Cisco Nexus devices and Cisco Nexus Fabric Extenders. Use this document in combination with documents listed in the [“Communications, Services, and Additional Information”](#) section on page 54.

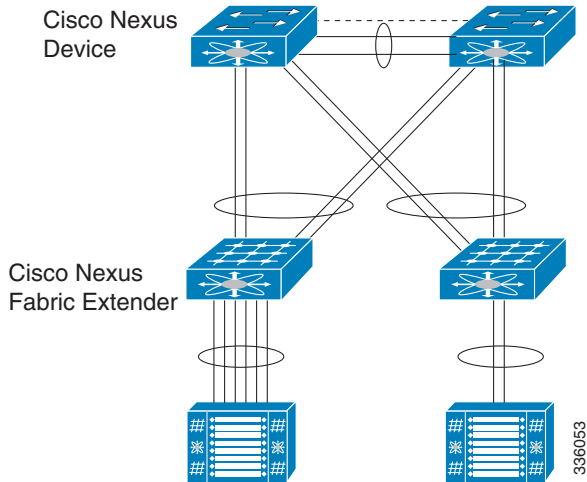
**Figure 12** Dual-Homed FEXs Connected to a Stub Switch

The following figure shows dual-homed FEXs connected to a stub switch.
